Sedona Fire District Fire Station Assessments

April 4, 2017

SEDONA FIRE DISTRICT FIRE STATIONS ASSESSMENT EXECUTIVE SUMMARY

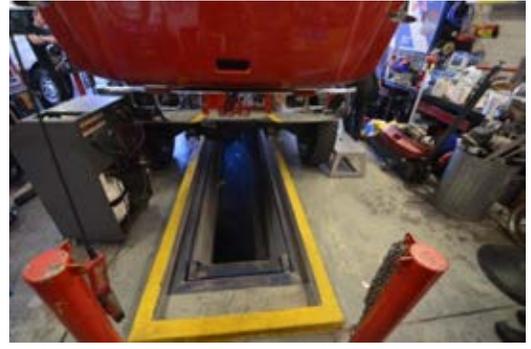
Maintenance Bay service pit does not meet current code

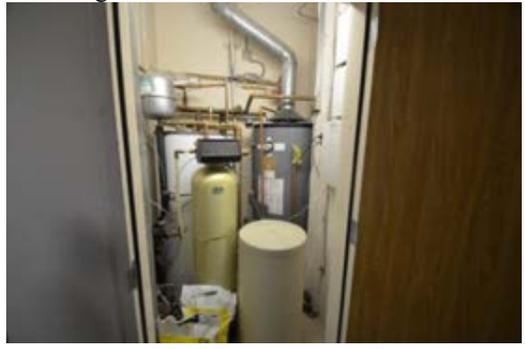
Water Heater/Softener closet on 2nd Level – visible signs of leaking

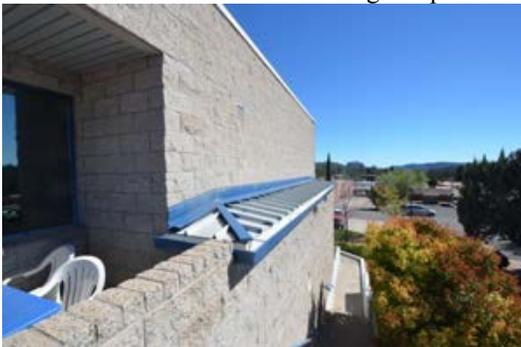
Paint is Failing @ Metal Roof

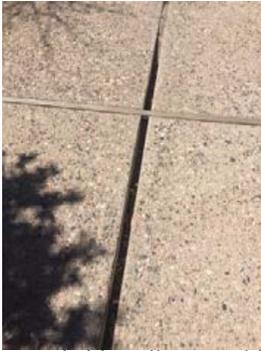
Wood sidewalk control joints do not meet ADA and potential tripping hazard.

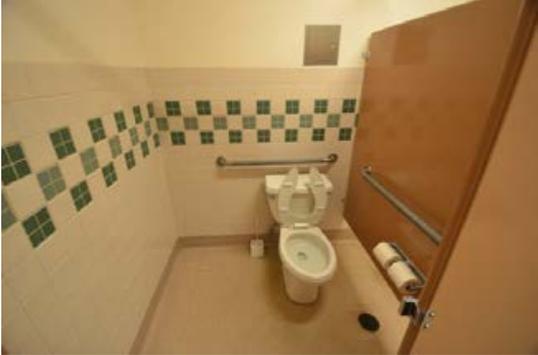
Public Restrooms are ADA accessible except for missing vertical grab bar

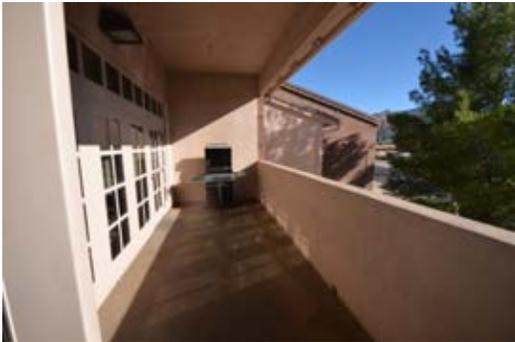
Balcony off of Dining room continues to leak

- Update current finishes in Fire Station Living areas (Kitchen/Dining/Dayroom)
- Repair or enclose 2nd level balcony to resolve leaking issues
- Repair or relocate evaporative coolers (Relocating to Ext. will increase Mezzanine floor area)
- Repair leaking HVAC condensate lines
- Repair Apparatus Room ceiling by adding drywall expansion joints

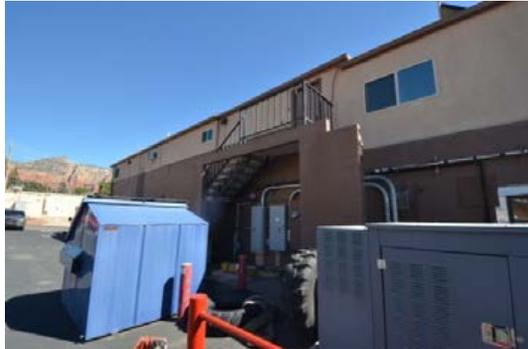
Exterior stair and guardrails do not meet current Building code
