Sedona Fire District Fire Station Assessments

April 4, 2017

LEA-Architects, LLC 1730 E. NORTHERN SUITE 110 PHOENIX AZ 85020 602-943-7511

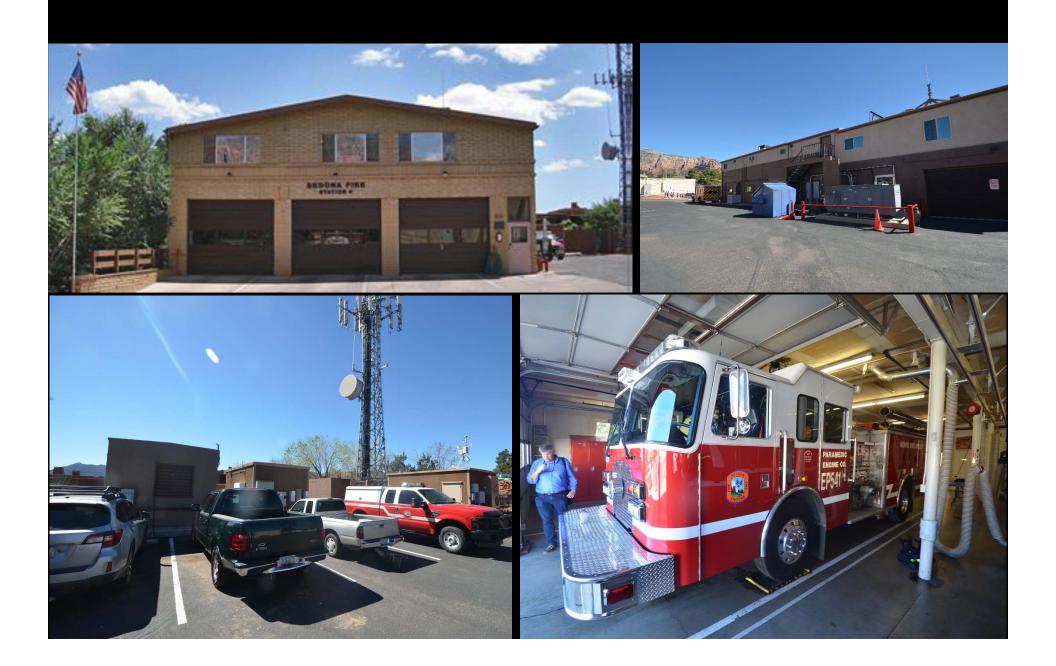
Sedona Fire Station No. 4 Key Issues

Split multi-level Fire Station ADA Non Compliance Issues

- Entry and Public/Staff Restrooms
- Multiple levels on 2nd Level
- Stairs (Int. and Ext.) do not meet Building Code or ADA

- No Drive-Thru Apparatus Bays
- Apparatus and staff/public parking drive are not separated

- Apparatus Bays /Doors are not tall enough for current Fire Apparatus
- Insufficient Apparatus Support Areas (Maint./SCBA/Storage/ Decon./ Dirty Laundry
- Turn-out Lockers located in Apparatus bays
- Current 2nd level floor heights restrict heights at 1st floor
- Stairs are not wide enough and are too steep
- Physical Fitness Equipment on 2nd level is causing floor damage
- Dorms are spread out through 2nd level
- Building additions cause leaking
- Multiple types of HVAC systems
- Exposed Electrical gear, conduit attached to exterior of structure

Does not meet current Building Code or Essential Facility Requirements

- Due to the numerous issues it is recommended that the existing Fire Station be replaced with a new Facility
 - See attached Concept Designs for Fire Station No. 4 located on same site.
 - Temporary Fire station will be required during the construction of the new Fire Station

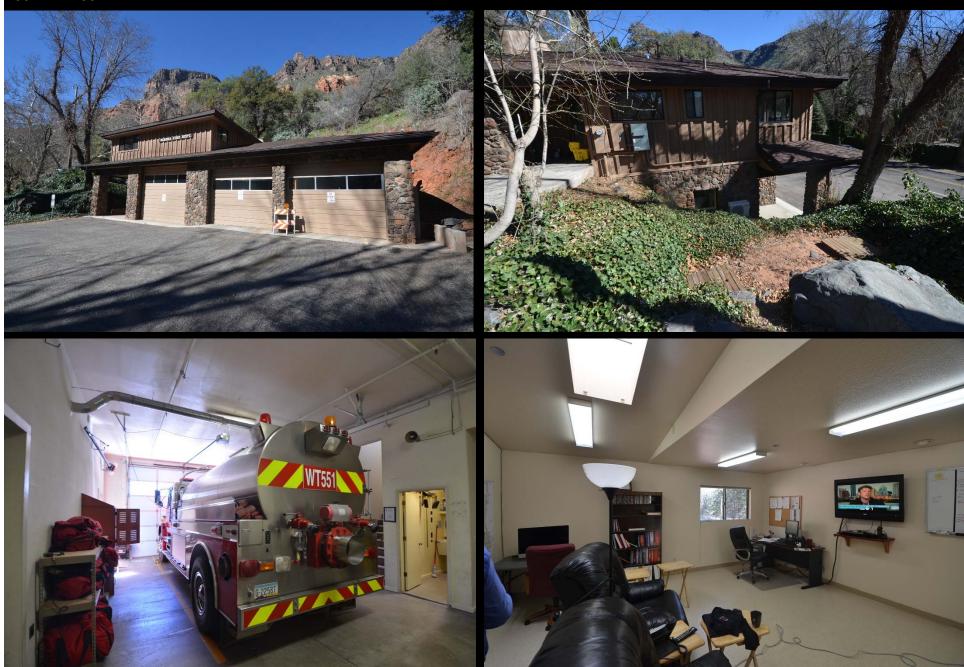
Sedona Fire Station No. 5 Key Issues

- Split multi-level Fire Station ADA Non Compliance Issues
 - ADA parking
 - Entry on both levels
 - Public/Staff Restrooms, Kitchen / Physical Fitness
 - Stairs do not meet Building Code or ADA

- Location relative to response area
- Insufficient staff / public parking
- No Drive-Thru Apparatus Bays and insufficient front apron depth
- Apparatus and staff/public parking drive are not separated

- Apparatus Bays /Doors are not tall enough or deep enough for current Apparatus
- Insufficient Apparatus Support Areas (Maint./SCBA/Storage/ Decon./ Dirty Laundry)
- Stairs are not wide enough and are too steep
- Physical Fitness Equipment is located in existing apparatus bay
- Residential Fire Sprinkler system is fed from well so water pump is not on emergency power
- Electrical system does not meet current Electrical code

Based on age of facility does not meet current Building Code or Essential Facility Requirements

- Due to the numerous issues it is recommended that the existing Fire Station be replaced with a new Facility
 - The Current site is of insufficient size to work for a new drive-thru Fire Station so new site should be explored.

- Fire Station No. 5 is currently well maintained and due to the minimum number of staff its immediate replacement may not be warranted until a new site or possible shared site with Park Service is obtained.
- If a new station is not immediately pursed continued maintenance and limited improvements (Updated kitchen, parking improvements) should be considered

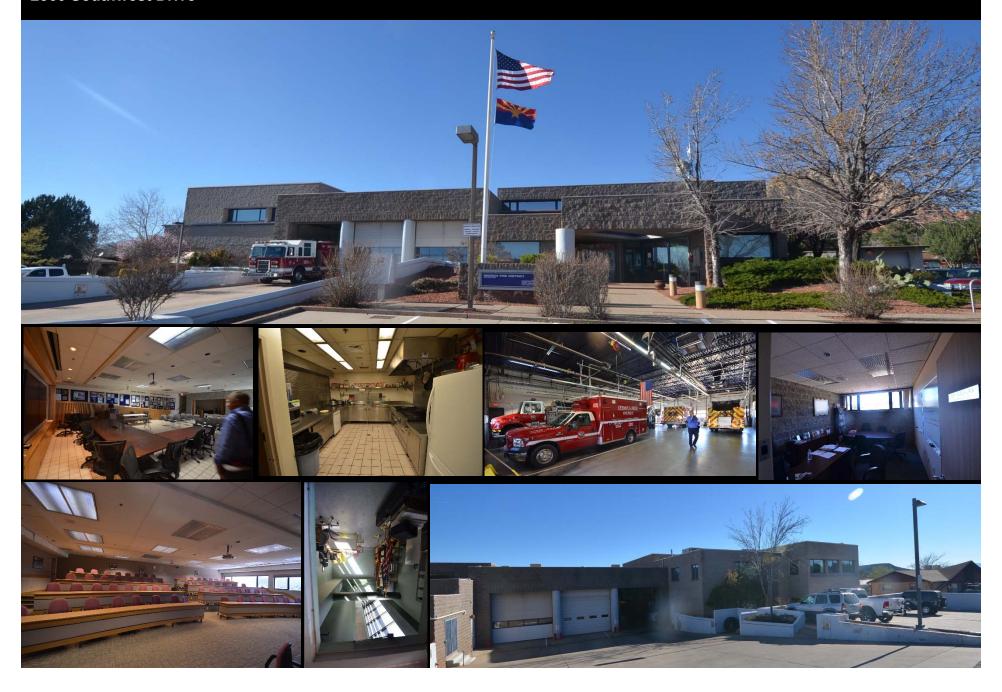
Sedona Fire Station No. 1 Key Issues

- Split 3 Level Fire Station / Administration ADA Non Compliance Issues
 - 1st Level Administration Public/Staff Restrooms
 - Kitchen on lower level adjacent to Meeting room
 - 2nd Level Administration Space not accessible by Elevator
 - Training Room on Fire Station 2nd Level not accessible due to inoperable Lift

- Kitchen not on same level as Dayroom/Dining/Patio
- Dormitories are on 1st and 2nd level

• Insufficient space to service larger vehicles and lack of work space

- Additional staff office (Private and Open office) are required
- Currently no Administrative Conference Room

- •Additional Parking is required for both Fire Station and Public Meetings
- ■Decorative sidewalks (wood joints) are dangerous

- Site
 - Additional Limited Parking due to relocated Maintenance Facility
 - Repair/Replace sidewalks

Relocate to adjacent Annex Building site which will allow for longer service bays

- Increased office space by utilizing one maintenance bay and FS Support areas
- Relocate IT Server Room to inside room to better control heat gain
- Remove portion of parallel corridor to gain additional office space
- Relocate CRM to allow for additional office and Staff Break Room

- Utilize existing Kitchen area to create Executive Session Board Room
- Utilize existing AV Room as new Staff Office
- Update existing finishes and Audio Visual
- Install new Elevator/Lift to allow ADA Access

- Relocate Kitchen to upper level adjacent to Dining/Dayroom/Patio
- Expand Dayroom/Dining into the large exterior covered patio
- Relocate (3) Dorms to upper level so all dorms are on same level
- Relocate Crew Office to upper level and move Physical Fitness to 1st Floor
- New Dorm layout that is more functional
- Increase showers in Men's Restroom and make both restroom ADA Compliant

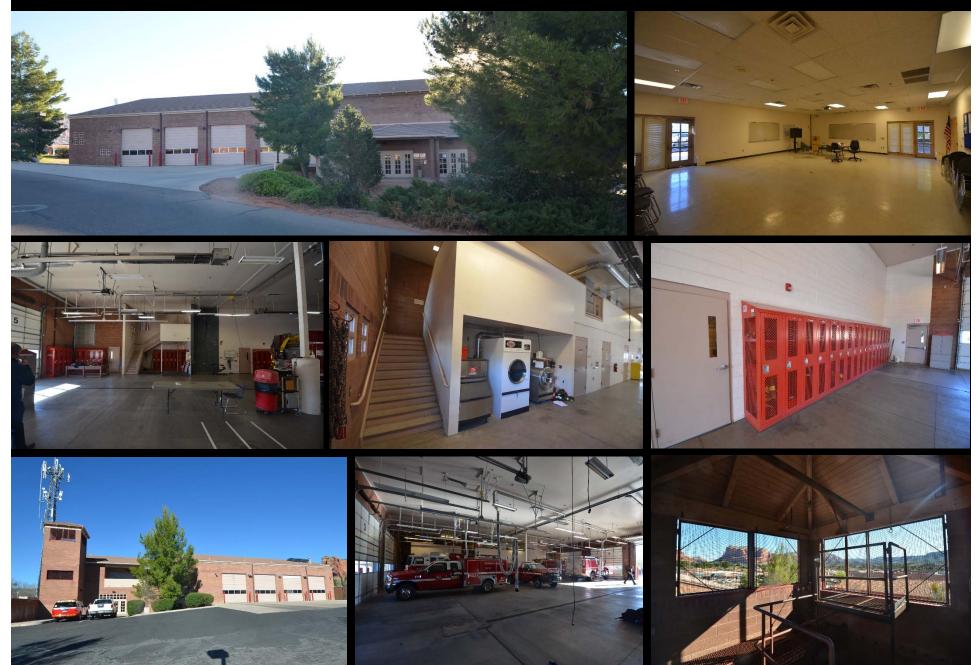
Sedona Fire Station No. 3 Key Issues

- 29 year old Station Originally Designed for Volunteer Fire Fighters
- Split 3 Level Fire Station / Training ADA Non Compliance Issues
 - 1st Level Exercise Toilets Rooms
 - 2nd level Fire Station Living Areas 2nd Floor Restrooms + Showers
 - Kitchen
- Fire Station
 - Evaporative Cooler @ Mezzanine Non Functioning Unit + Continuously Leaks
 - Plumbing Recirculation Issues
 - Leaking Condensate Lines @ Mechanical Units
 - Turn-out Lockers within Apparatus Bays
- Site
 - Drainage issues (Ponding on asphalt drive)

Install concrete at portion of drive and install area drain to improve drainage

- 1st level public areas are ADA compliant with some very minor upgrades
- Due to cost ADA access to 2nd level FS Living areas is not recommended

- Update current finishes in Fire Station Living areas (Kitchen/Dining/Dayroom)
- Repair or enclose 2nd level balcony to resolve leaking issues
- Repair or relocate evaporative coolers (Relocating to Ext. will increase Mezzanine floor area
- Repair leaking HVAC condensate lines
- Repair Apparatus Room ceiling by adding drywall expansion joints
