Sedona Fire District Fire Station Assessments

April 4, 2017

SEDONA FIRE DISTRICT FIRE STATIONS ASSESSMENT EXECUTIVE SUMMARY

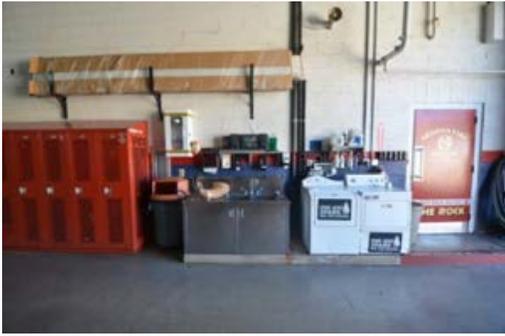
Turn-out lockers located in apparatus bay.
Step into fire station

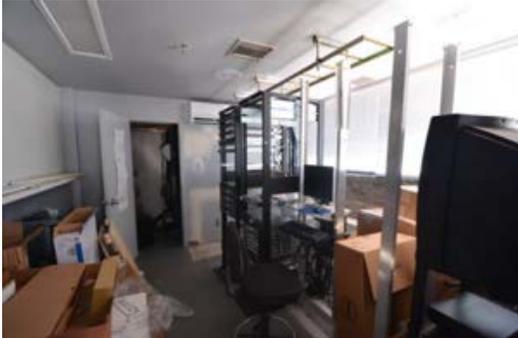
Communications equipment located along windows
increasing heat load

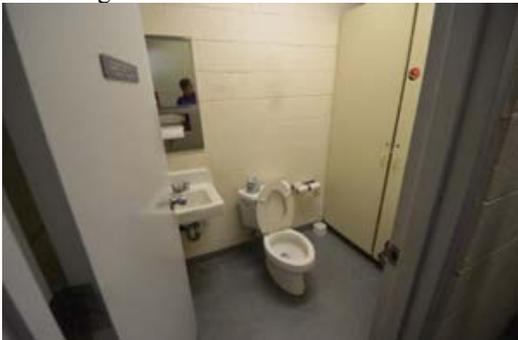
Non ADA restroom adjacent to Apparatus Bays

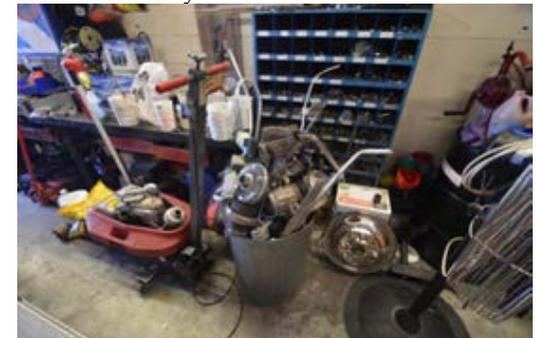
Insufficient work bench areas in Maintenance Bays

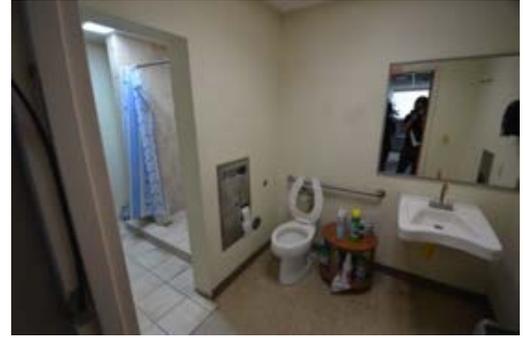
1st Level Restroom shower is not ADA accessible

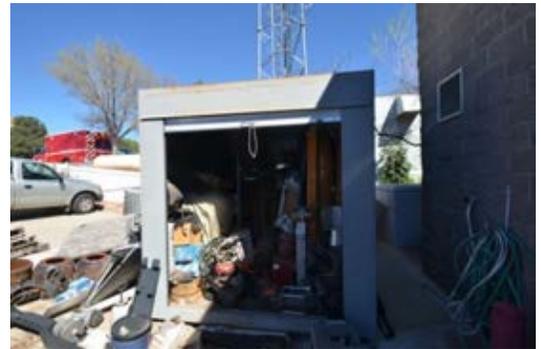
Storage Container on Maintenance Bay Apron

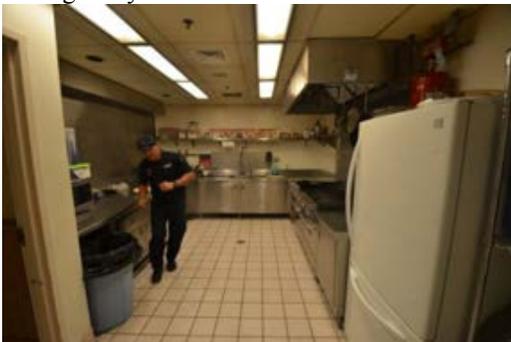
Fire Station Kitchen approx. 3' lower than Dining

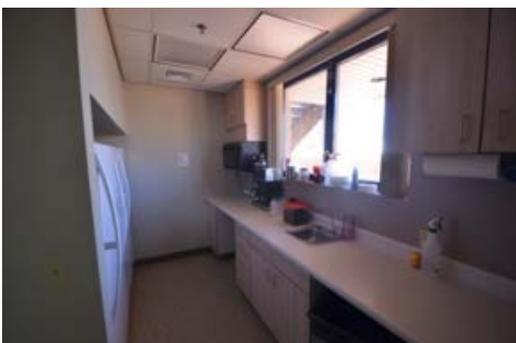
Insufficient Kitchen area adjacent to Dining

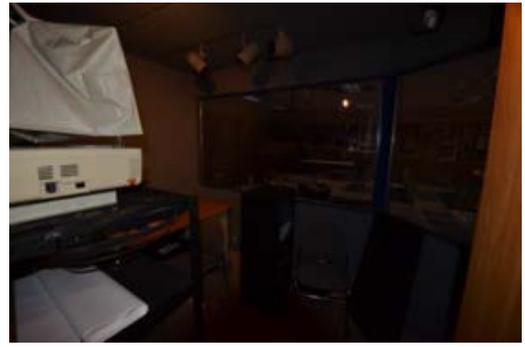
AV Room adjacent to Meeting primarily used for Storage

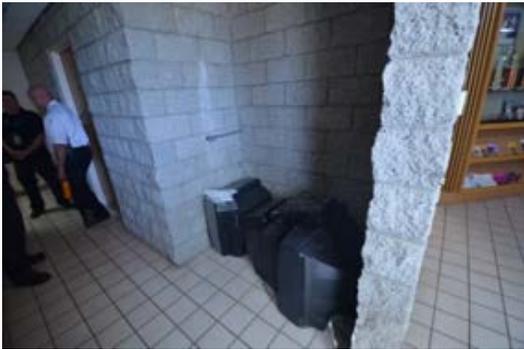
Unused vending machine alcove adjacent to meeting Room

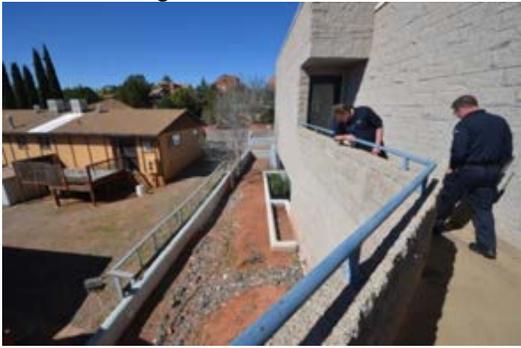
2nd Level deck does not have enough slope to drain

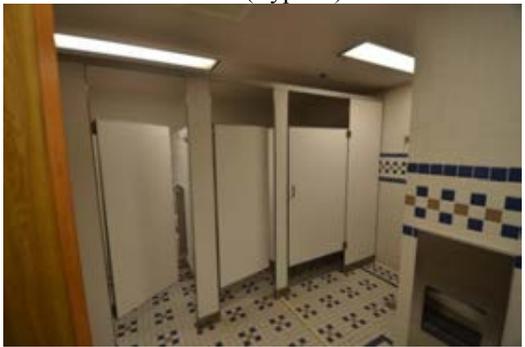
2nd Level Restroom ADA accessible except shower

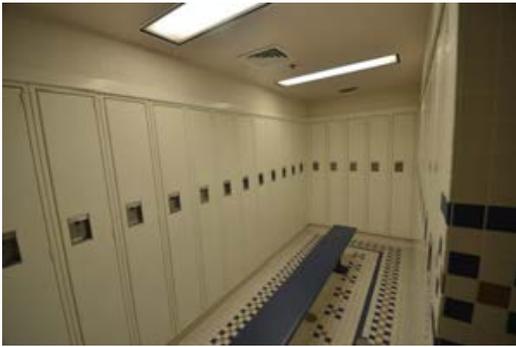
Locker areas in Restroom are not used

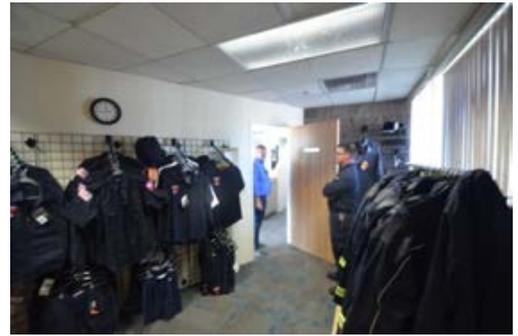
Uniform Storage Room added in Lobby area

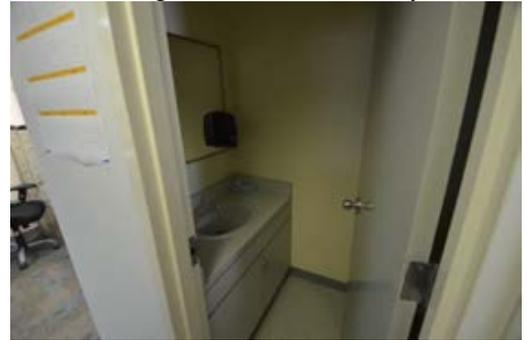
Fire Prevention Restroom is not accessible

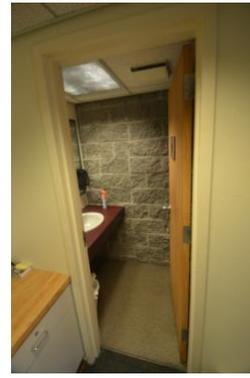
2nd Floor Restroom is not ADA accessible

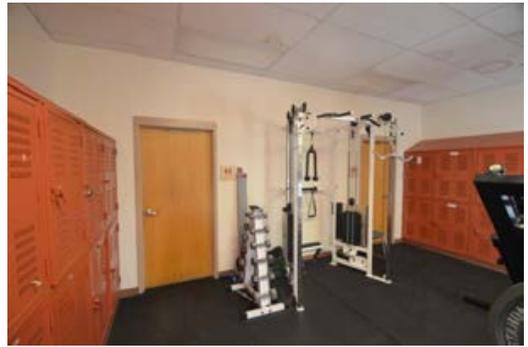
Lockers in exercise room are not typically used

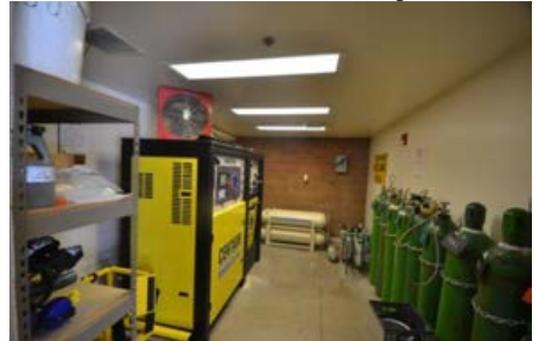
SCBA compressor/Fill Station/O2 cylinders in room without ext. ventilation

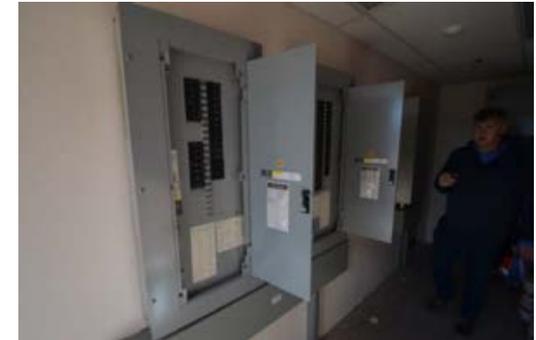
Electrical room adjacent to Mech. Yard.
Electrical panels do not have main breakers

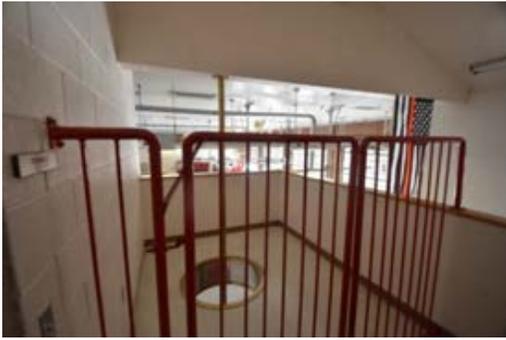
Gate was added in Front of pole drop for safety

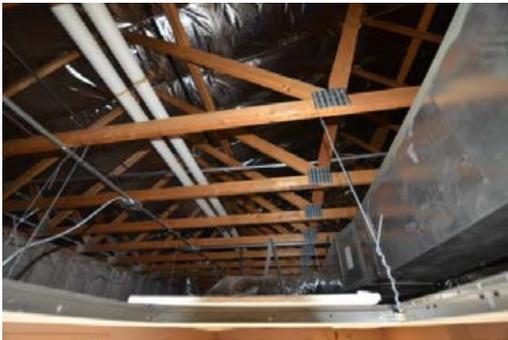
Open trusses w/ large unconditioned area above ceilings

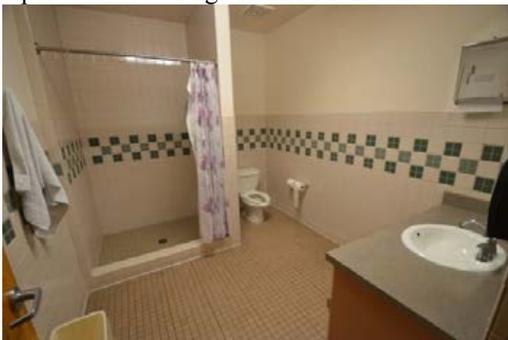
Typical shared restroom between dorms are not ADA accessible

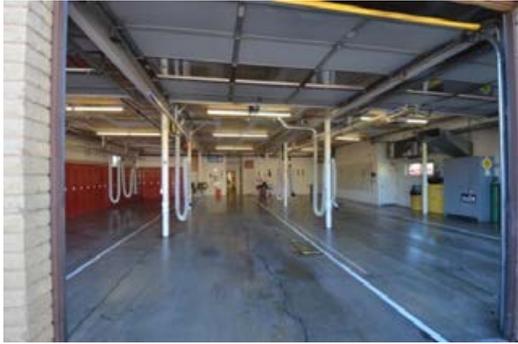
10' high apparatus bay doors do not allow for current fire apparatus

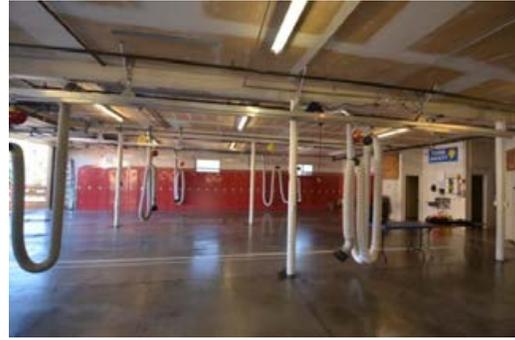
Columns in apparatus bays
Turn-out lockers in apparatus bays

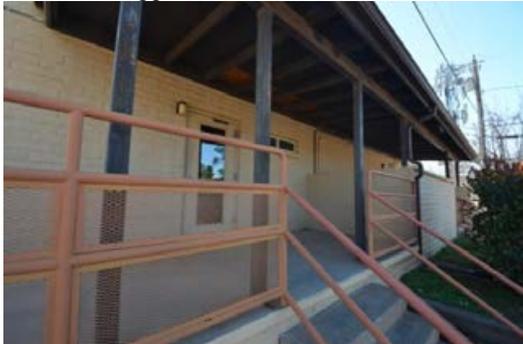
Handrail spacing @ auxiliary building does not meet building code

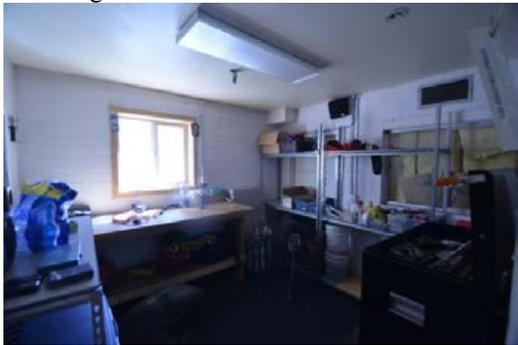
Windows covered in Maintenance shop

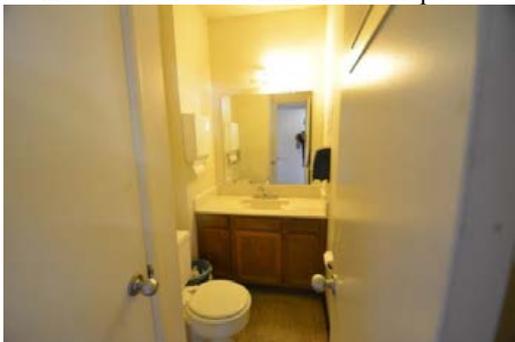
- 1) The Lower floor would require full ADA accessibility if the Fire Station is Substantially altered
- 2) The upper floor is 5,000 SF so exceeds 3,000 SF and would require full ADA accessibility if the Fire Station is Substantially altered
- 3) Restrooms are not ADA compliant and would require full compliance if the Fire Station is Substantially Altered.

Restroom adjacent to apparatus bays does not meet ADA

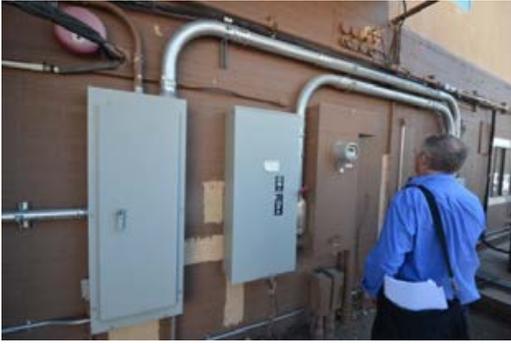
Wall mounted electrical panels & exposed conduit on exterior walls of building

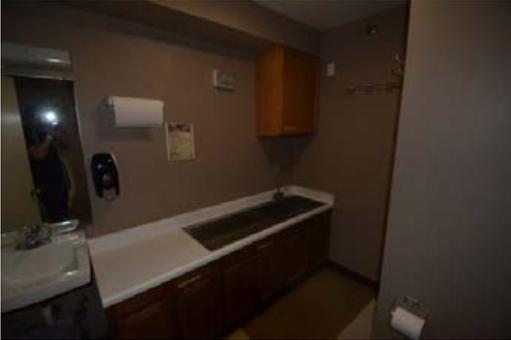
Non-ADA restroom with shower
Exist dark room sink

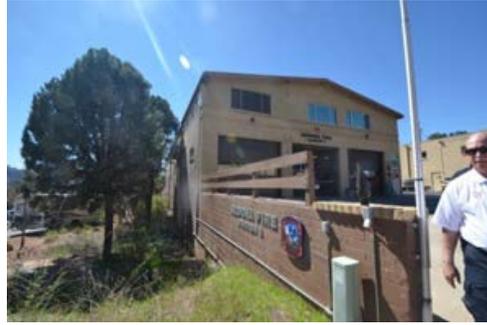
Sedona FS#4 sign & front elevation
Exhaust fan on existing wall extends over property line

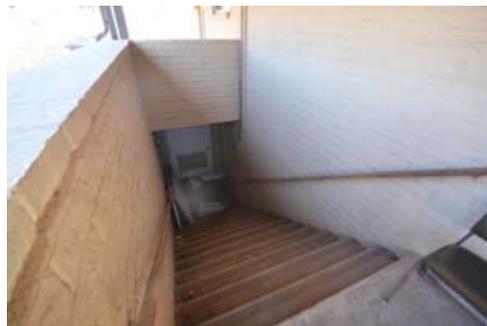
Exterior stair to lot level not used due to Flooding

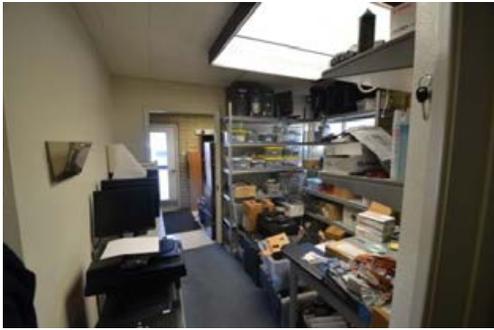
Communications equipment in annex building

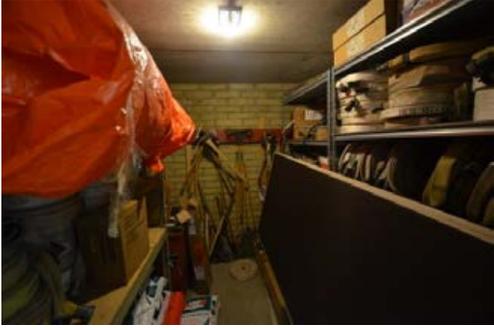
Hose storage in annex building

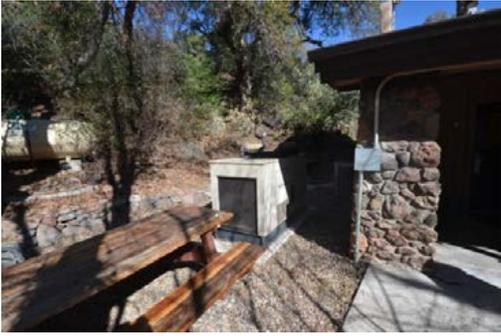
Upper Level entry/Patio

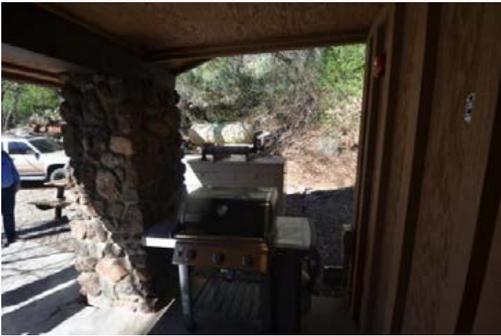
Gas BBQ located adjacent to entry door

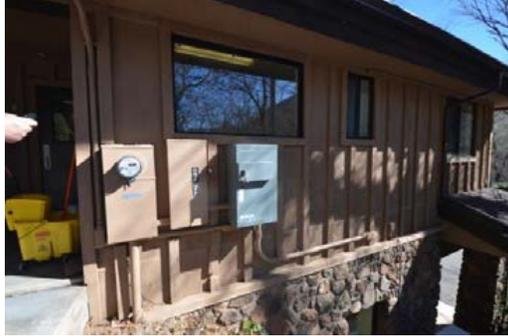
Electrical service adjacent to upper level entry

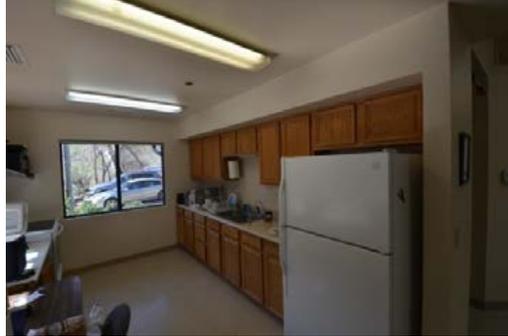
Residential Kitchen is not ADA compliant

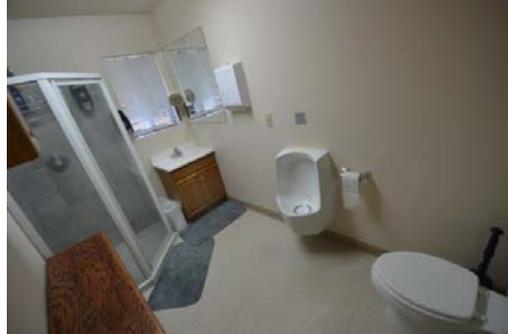
Bathroom is not ADA accessible

- Relocate Kitchen to upper level adjacent to Dining/Dayroom/Patio
- Expand Dayroom/Dining into the large exterior covered patio
- Relocate (3) Dorms to upper level so all dorms are on same level
- Relocate Crew Office to upper level and move Physical Fitness to 1st Floor
- New Dorm layout that is more functional
- Increase showers in Men's Restroom and make both restroom ADA Compliant

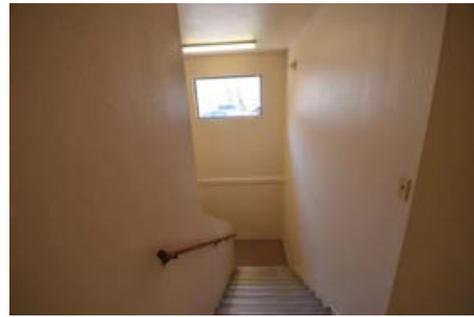
Stair does not meet current building code

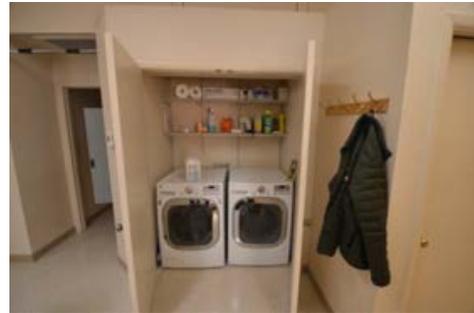
Laundry in closet adjacent to Dayroom

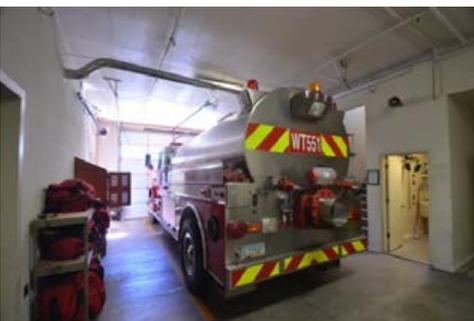
Water Tender w/exhaust system in Apparatus bay
